# **INDOOR AIR QUALITY ASSESSMENT**

**Church of the Nativity  
4 Green Street  
Merrimac, Massachusetts**

Prepared by:  
Massachusetts Department of Public Health  
Center of Environmental Health  
Emergency Response/Indoor Air Quality Program  
January 2007

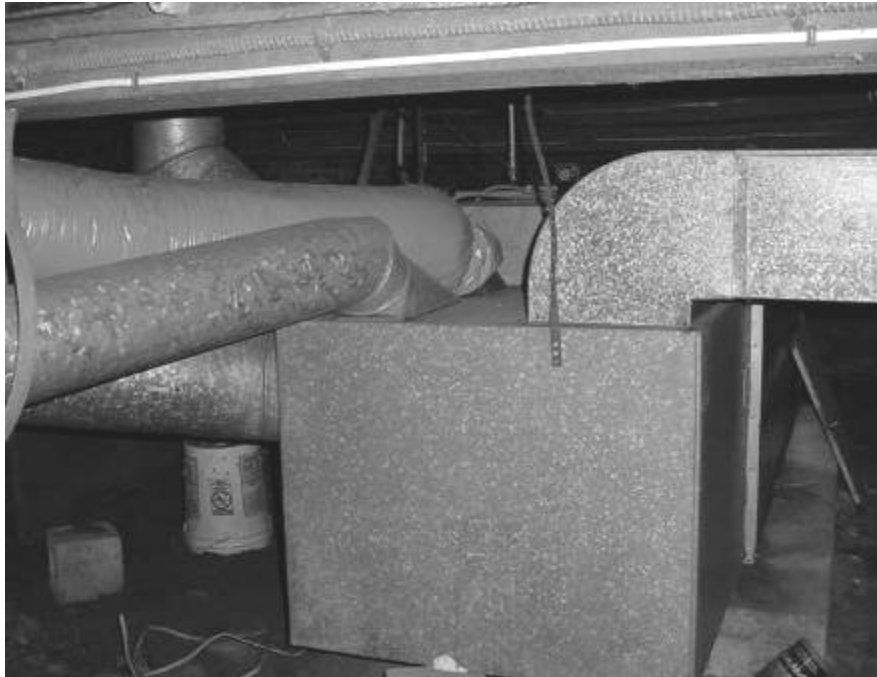
**Picture 1**

As indicated, the building resides over a crawlspace. The building's heating, ventilating and air condition (HVAC) system consists of a combination furnace/forced hot air air-handling unit (AHU) that is located in the crawlspace (Picture 1). Four floor-mounted

**HVAC System Church Crawlspace**

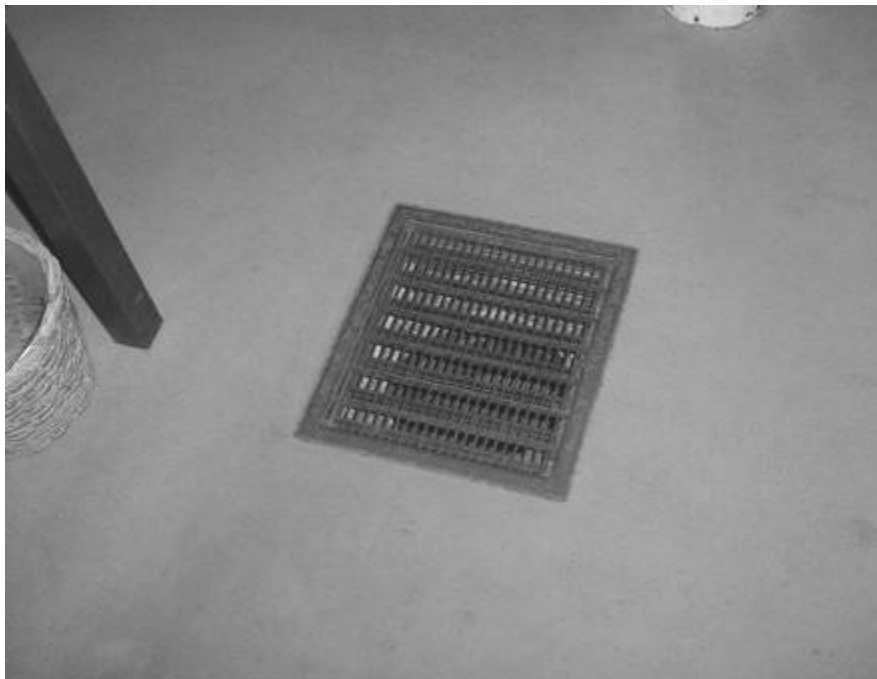
**Picture 2**

heating vents provide tempered air to the main section of the building. The heating vent grates in the floor of the main hall are heavily corroded, indicating the presence of moisture in the ductwork (Picture 2).

**Heat Vent in Floor of Congregation, Note Corrosion**

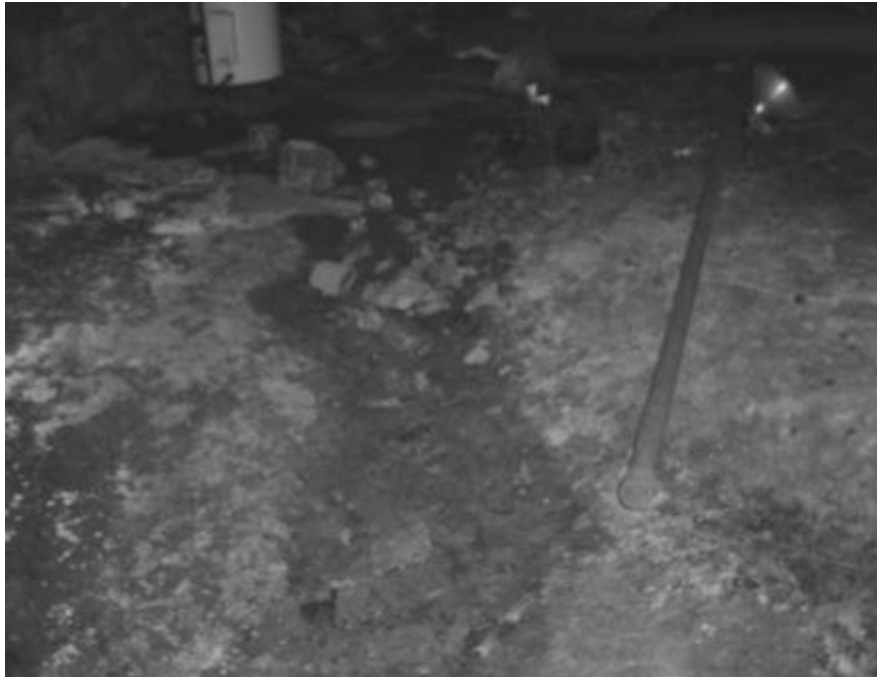
**Picture 3**

The church crawlspace consists of a dirt floor (Picture 3). The crawlspace appears to be subjected to significant water penetration as suggested by a sump pump installed in the area (Picture 4); however, no standing water was observed. Crawlspace air can migrate into the occupied areas via two pathways: the AHU and breaches. Filters are installed in the AHU to remove particulates from the system's air stream. These filters should be sized to fit flush inside the system. Once placed inside, the filter cabinet is sealed behind a door or, in this case, sheet metal panel held in place by screws. The air filters used in the AHU are larger than those standard to this system, therefore the cabinet cannot be properly sealed (Picture 5). In this condition, crawl space air by-passes the filters, drawn into the AHU and distributed to occupied areas. Please note that the flue damper for the boiler exhaust is located in close proximity to the filter opening (Picture 6). This configuration can draw products of combustion through the flue damper into the AHU via the open filter access.

**Crawlspace of Church**

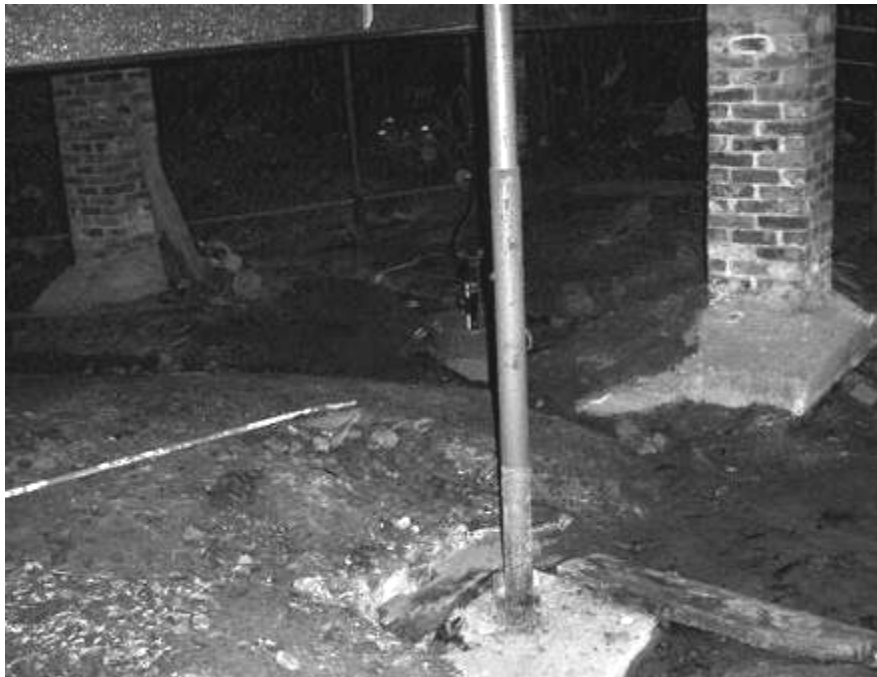
**Picture 4**

**Sump Pump Installed in Floor of Crawlspace**

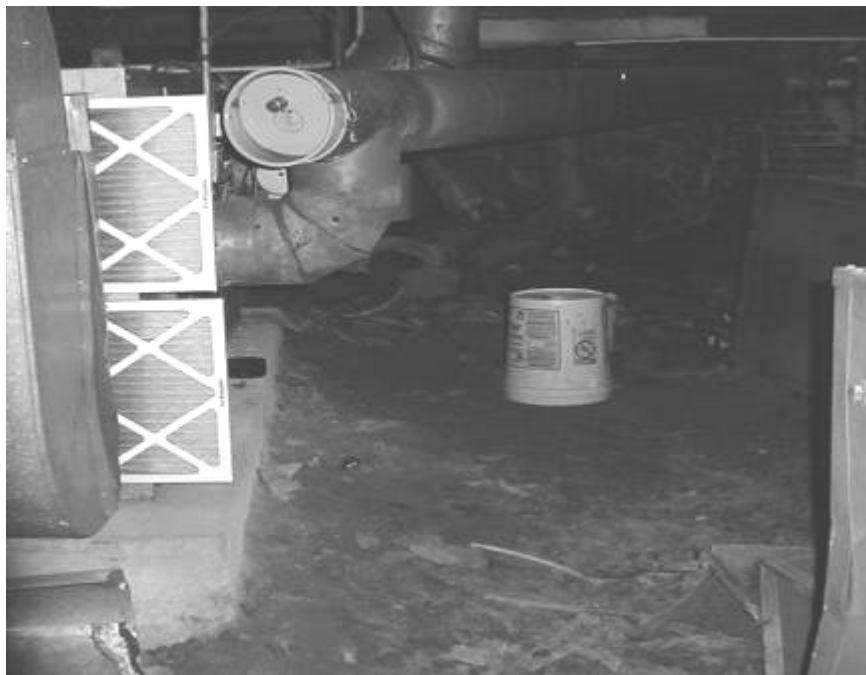
**Picture 5**

**Filter Protruding from the AHU**

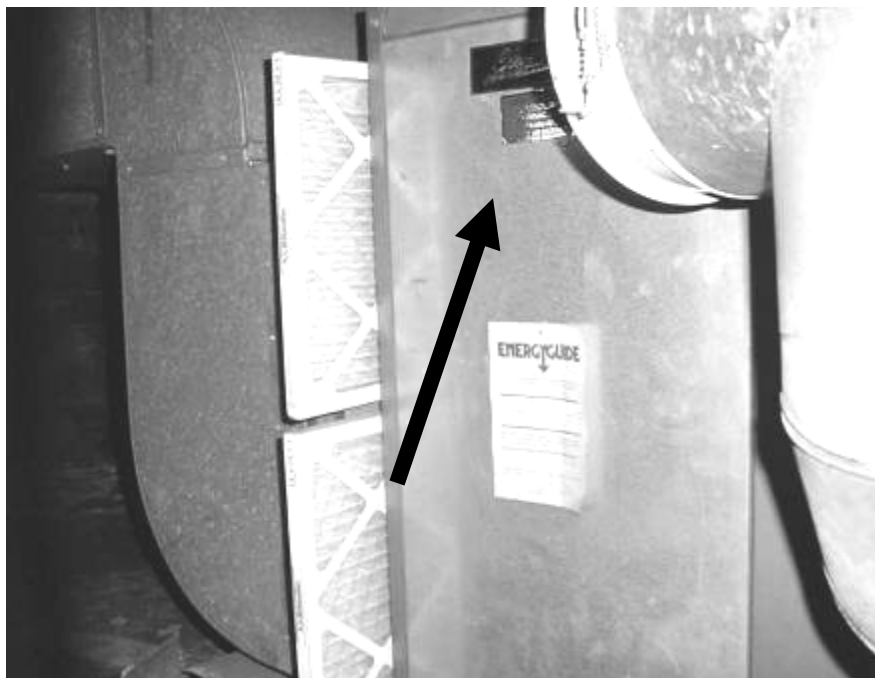
**Picture 6**

**Exhaust Vent in Close Proximity to the Flue Damper**

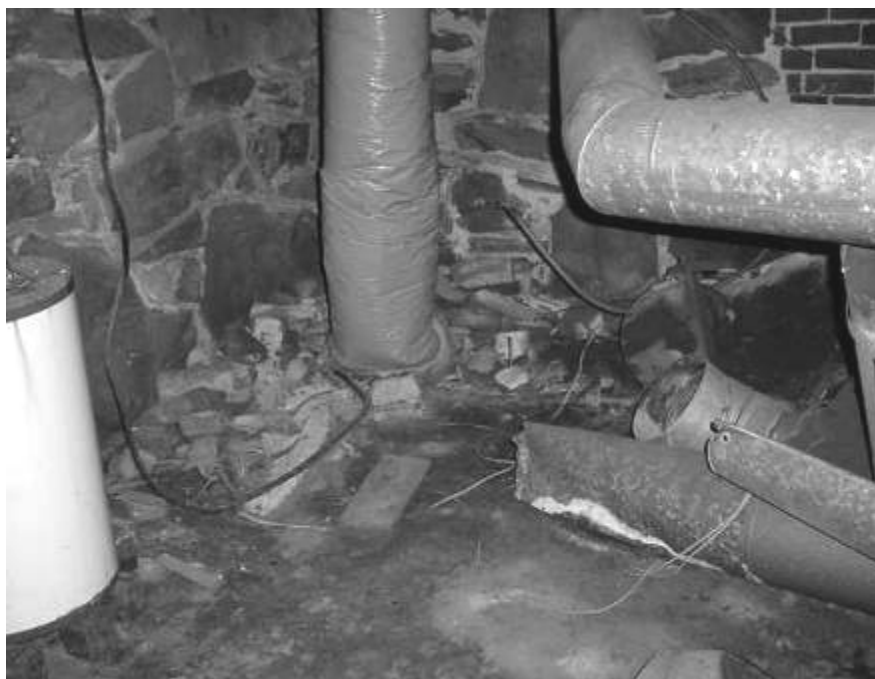
**Picture 7**

Flexible duct was added to the AHU, presumably to provide conditioned air to a church wing added after the original construction. This flexible duct is damaged and currently empties air into the crawlspace (Picture 7). In this condition, air escaping from the duct can pressurize the crawlspace and be forced through seams in the floor or walls.

**Flexible Duct Terminating on the Floor of Crawlspace**

1. Acquire filters of an appropriate size for use in the AHU. Refrain from storing replacement filters in the crawlspace (Picture 8).
2. Acquire a new appropriately sized sheet metal panel to affix over the filter access opening.
3. Reconnect the flexible duct to its register.
4. Consider removing as much wood/cardboard and other materials that can support mold growth from the floor of the crawlspace.

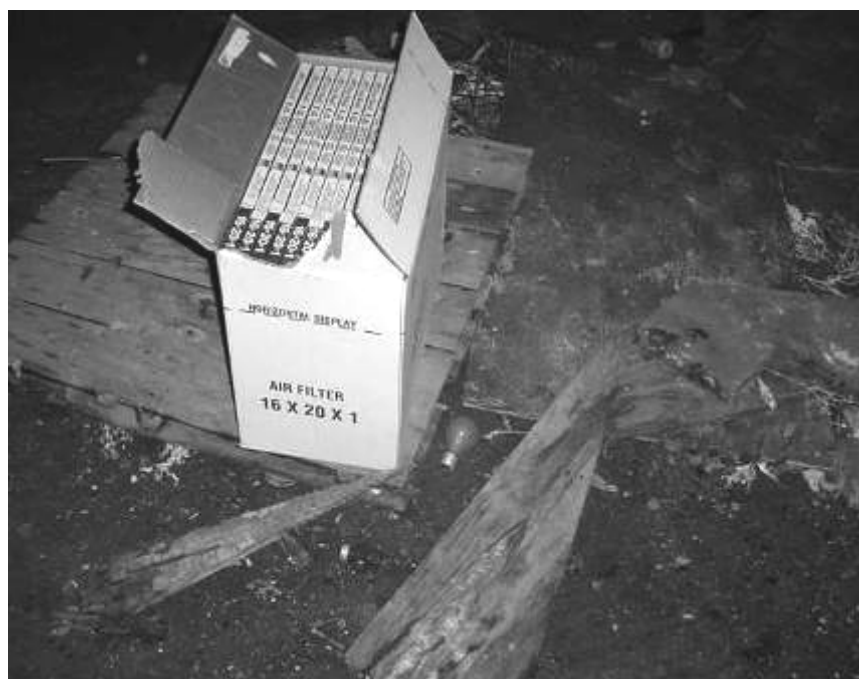
**Picture 8**

A significant amount of rotted wood and other discarded materials were observed in the crawlspace (Picture 8). If moistened for prolonged periods of times, these materials can serve as media for mold growth. The US Environmental Protection Agency (US EPA) and the American Conference of Governmental Industrial Hygienists (ACGIH) recommends that

porous materials be dried with fans and heating within 24 to 48 hours of becoming wet (ACGIH, 1989; US EPA, 2001). If porous materials are not dried within this time frame, mold growth may occur.

**New Filters Stored on Top of Rotting Wood**
